CARR-1585

405 S. Main Street, Mt. Airy

**Maryland Historical Trust
State Historic Sites Inventory Form**

historic Calvary United Methodist Church Parsonage

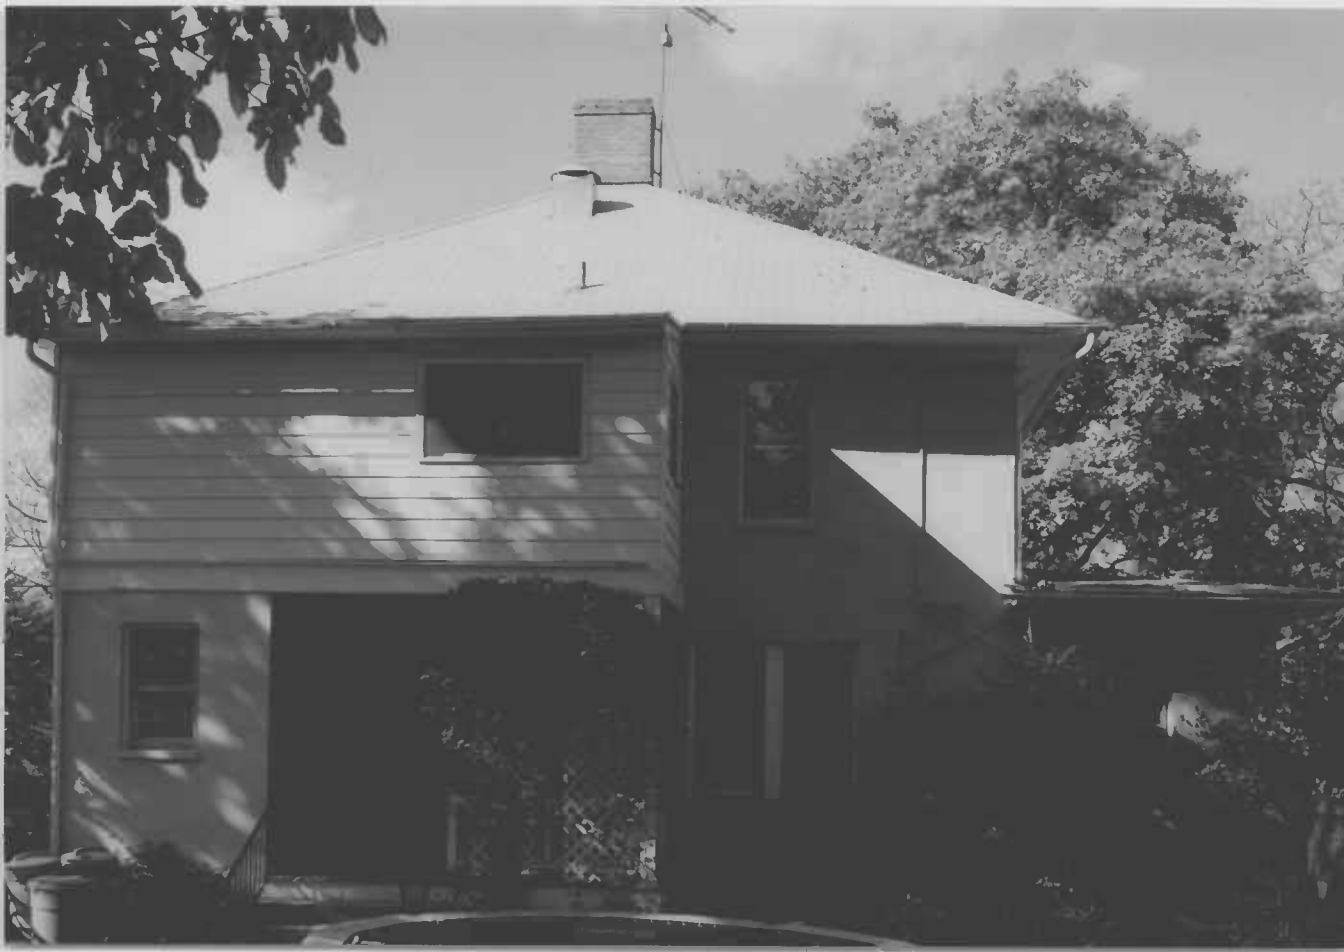
10F5

S.E. Elevation

The first story of the southeast elevation has a projecting pantry on the south that has a 1/1 sash set south of the south bay. The south bay has a one light over three light and paneled door. The east bay has paired 1/1 sash. The second story has a porch that is now enclosed with aluminum siding and 2 one light casements. This porch covers the south two-thirds of the house with a turned post under the east corner. The east bay has a 1/1 sash. On the southwest elevation, the first and second stories each have two 1/1 sash. In the center between the first and second stories, there is a 1/1 sash set at the stair landing level.

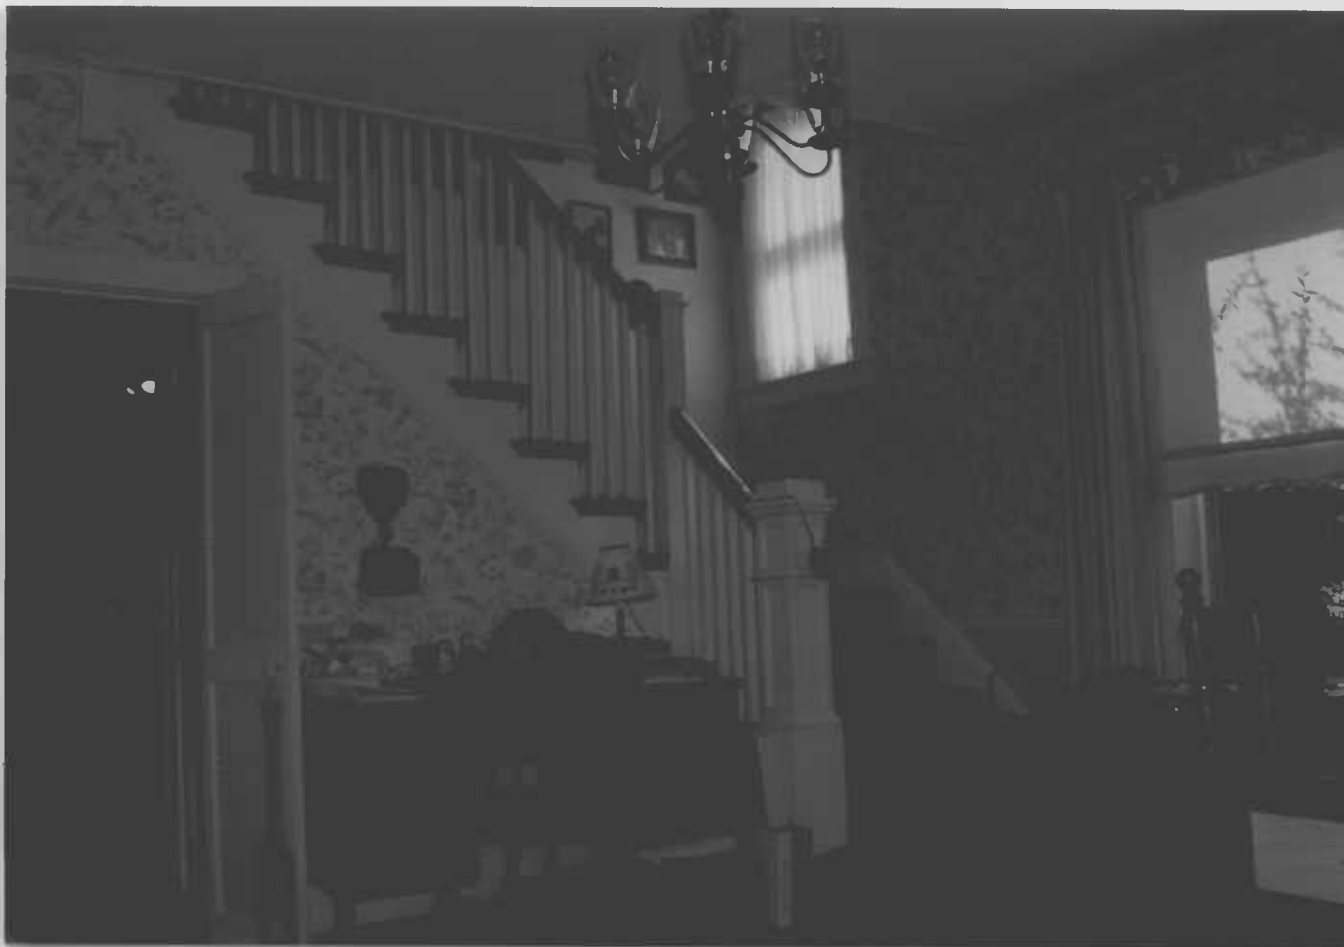
20FS

West Rm - VW South Elevation

The first floor plan is divided into four rooms with a pantry off the southeast end of the house set to the south and an office off of the northeast end of the house set to the east. The first story has oak flooring running northeast to southwest throughout. The west room is an entrance foyer with a two run stair in the south corner. It has a paneled newel post and rectangular in plain balusters and a molded hand rail. The architraves are plain and are rounded off on the corners and are mitered. They were apparently natural varnished pine originally. The northeast elevation has a double wide door opening leading to the north room. The north room has a brick fireplace in the south corner with a wood mantel that has a reeded architrave and a dental cornice. This room has a double wide door opening on the southeast

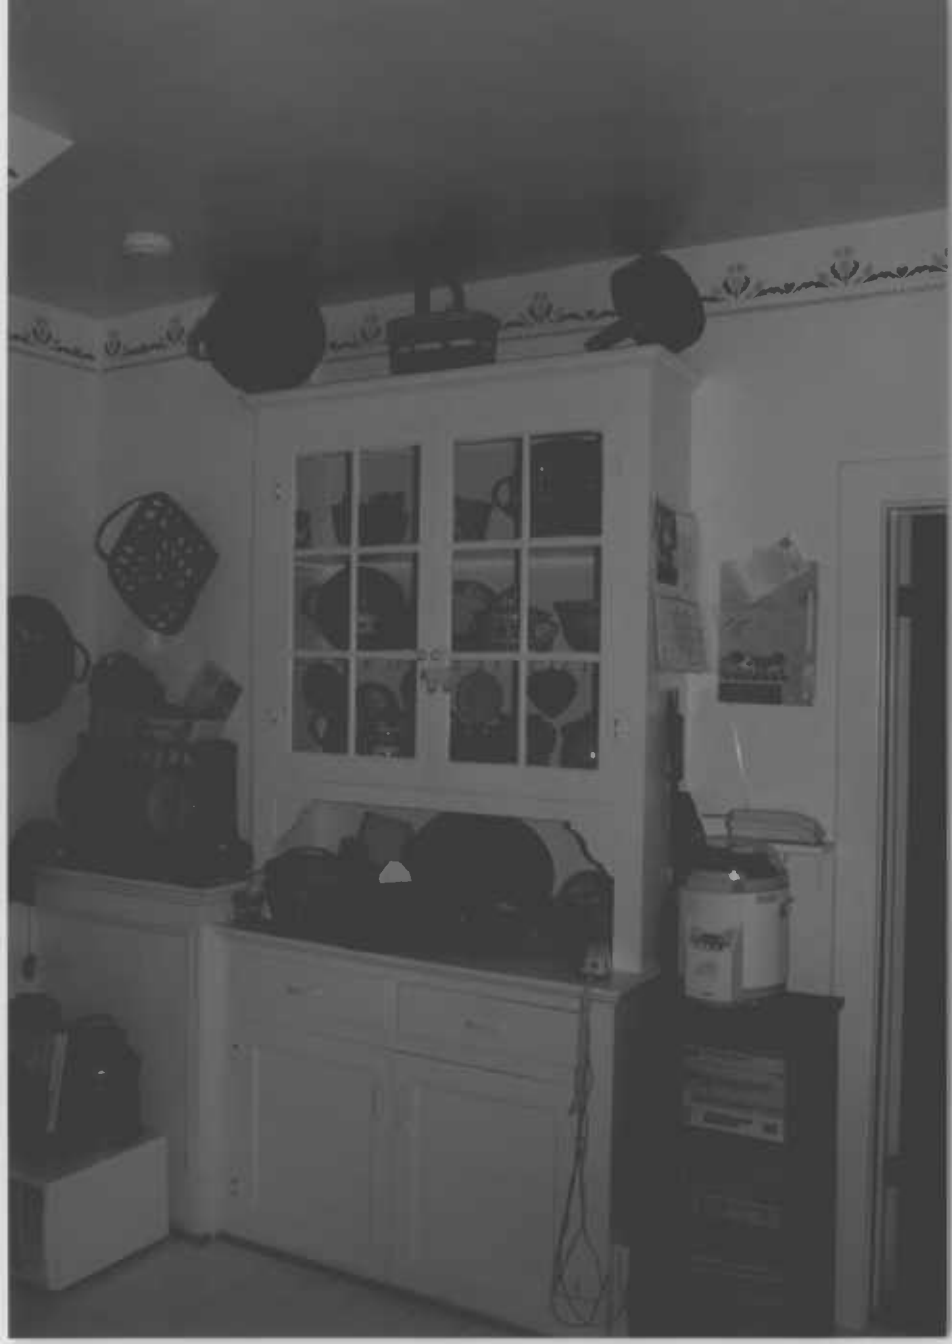
3 OF 5

Neg Loc.: Maryland Historical Trust
South Rm - Cupboard

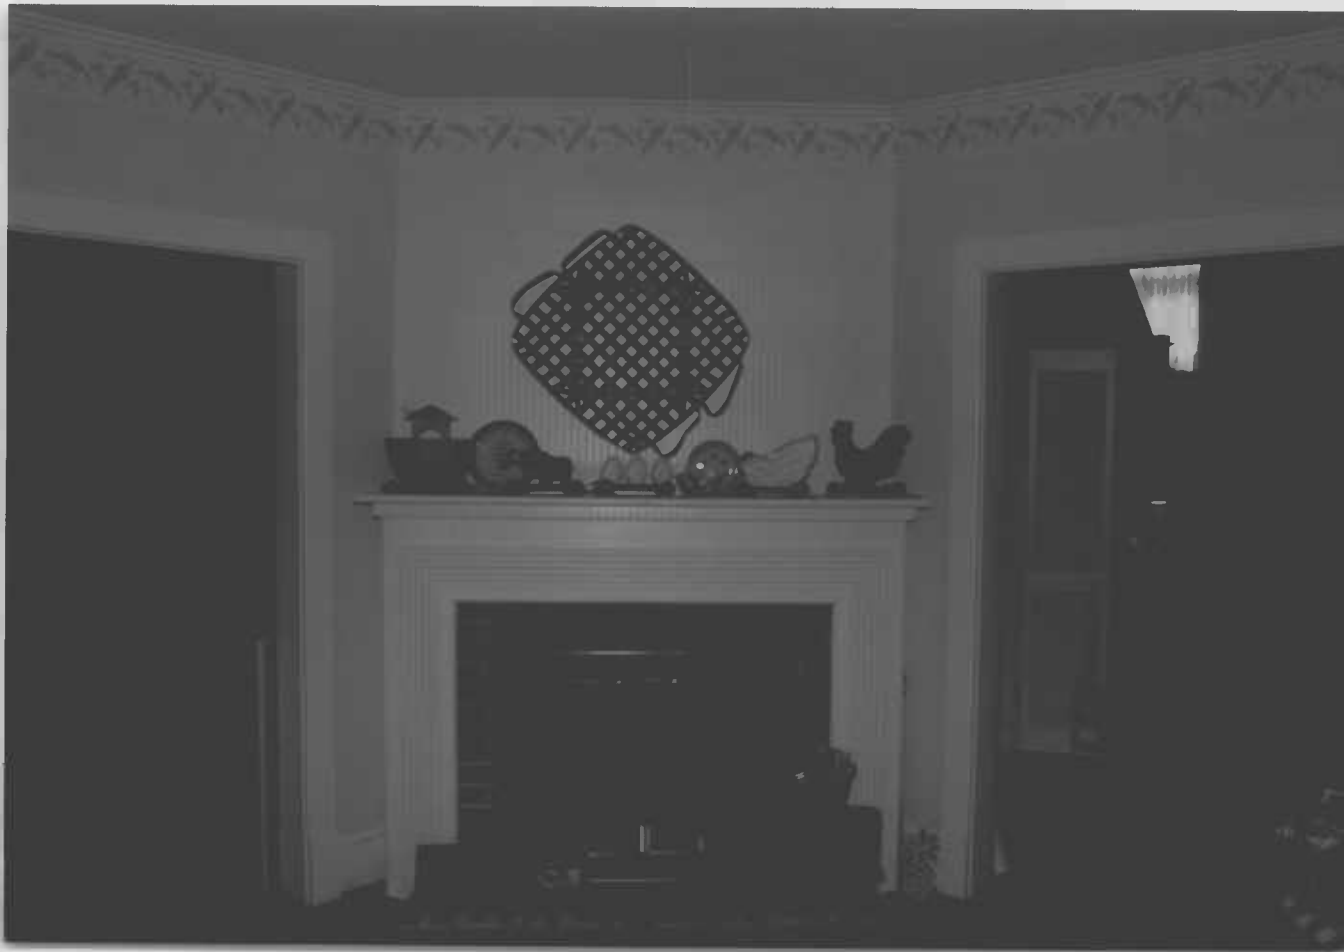
North Rm - VW South Elevation

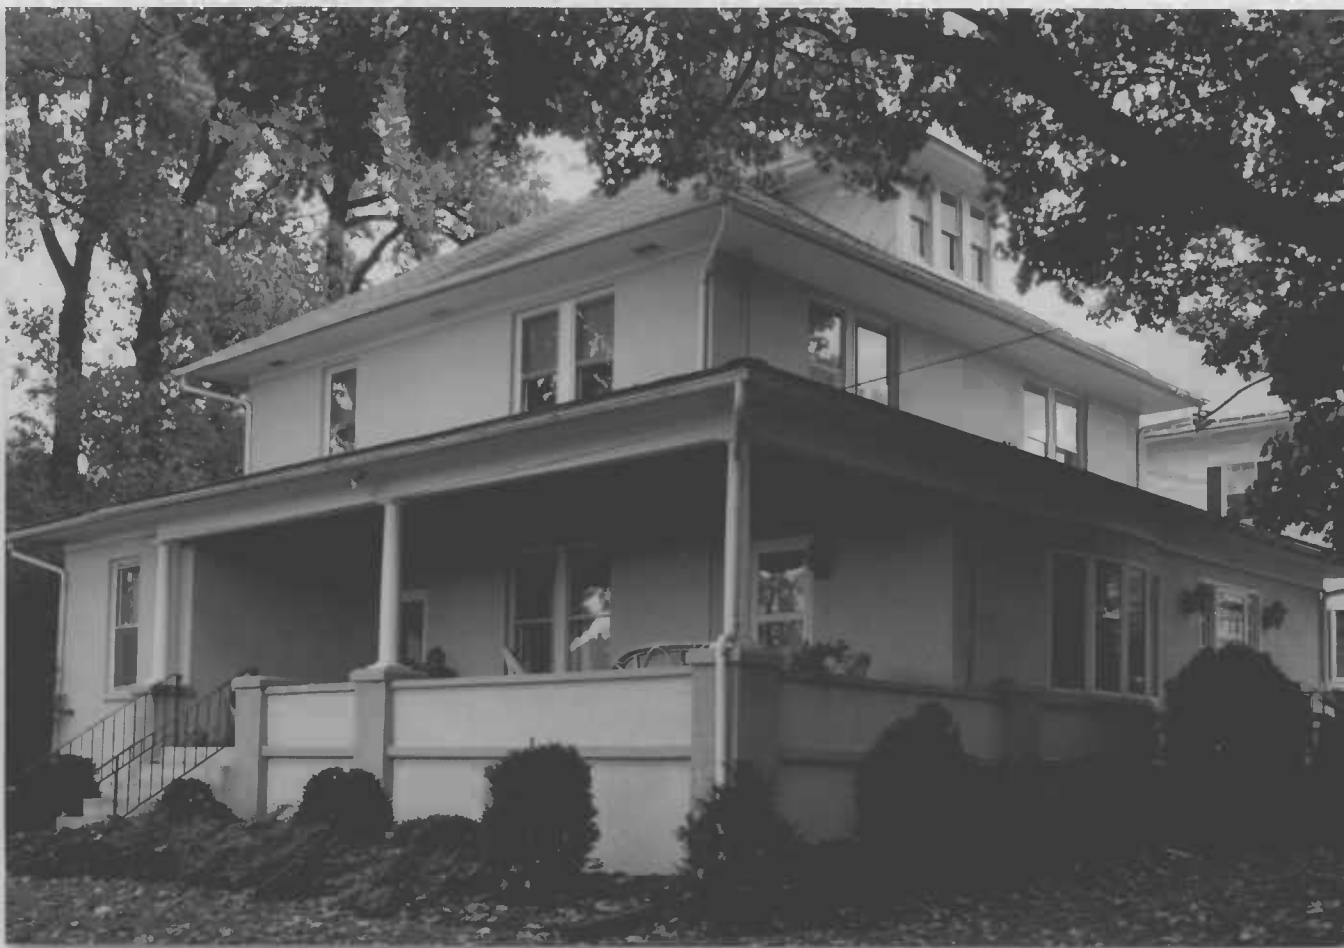
50F5

NE & NW Elevations

On the northwest elevation, the first story has a porch that is enclosed on the northwest with a bay window and a door with side lights. This porch wraps around on the northeast elevation but is not enclosed there. The second story of the northwest has paired 1/1 sash in both bays. The house has a wide over-hanging eave. There is a dormer with three 1/1 sash. The dormer has a hip roof with a widely over-hanging eaves. The sides of the dormers have diamond pattern asphalt shingles. The northeast elevation on the first story has a room at the east end of the porch. This is not a later enclosure of part of the porch but appears to be an original room. The room has a 1/1 sash on the northeast elevation and a wide over-hanging eave. The porch has Tuscan columns set on stuccoed piers with stuccoed balustrade walls between the piers. In the center of the first story is a door with one light over two square panels that have wreaths and swags carved on them and one lined panel at the bottom of the door. Above the two square panels, the rail has carved foliage. The north bay has paired 1/1 sash. The porch is enclosed at the north end with a door that has nine lights over two panels. The second story has a 1/1 sash in the east bay and paired 1/1 sash in the north bay.
